**UPPER PATUXENT RIVER WATERSHED RESTORATION ACTION STRATEGY (WRAS)
FORM 1 -- Catchment Information**

Subwatershed: Bear Branch

Site Name: Mayfair Subdivision Address: Bonnett Ln, Bonnett Rd, Mayfair Dr, Mayfair TerSite Owner: varies (contact Mayfair Homeowners Association)State Plane Coordinates of Site Centroid: X: 1344682 Y: 517742 Date: 3/21/03Personnel: JA, PM Weather: overcast, 60F degArea (ac): 6.3 Impervious Area (ac): 1.3Percent Impervious: 20% Soil Recharge Factor (S): 0.12WQ_v (required): 0.12 Re_v (required): 0.01Property Area (ac): 38.8 Property Area Included in Site: 16 %Amount of Catchment Occupied by Site: 80 %

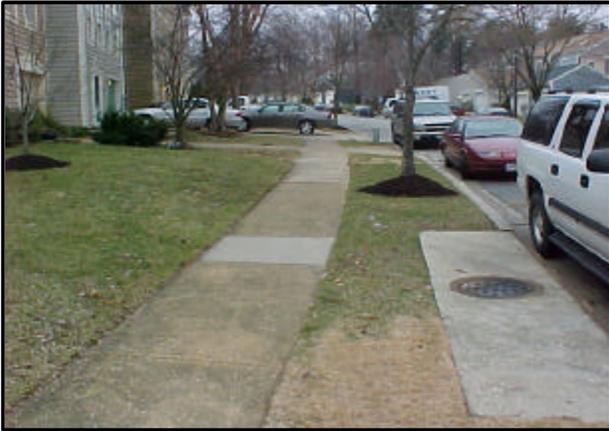
- No. 410 Description: looking west at north side of street
- No. 411 Description: looking west at north side of street
- No. 412 Description: looking east from watershed boundary
- No. 413 Description: looking north from Contee Road at Bear Branch
- No. _____ Description: _____

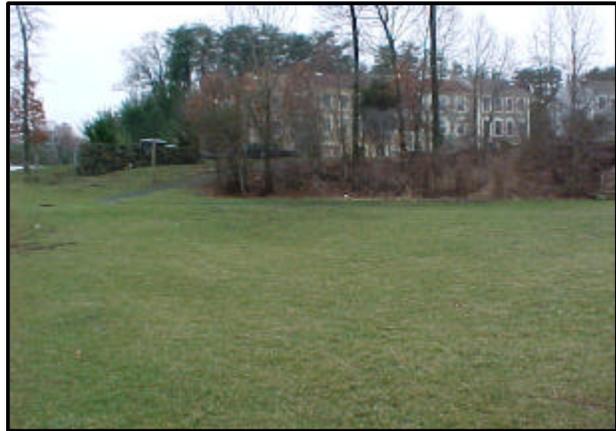
413

Comments At the time of the field inspection the creek was overflowing and passing over Contee Road.
The property acreage provided above is for the entire Mayfair Subdivision.
